Why did Palau Bridge collapse?

Synopsis

The failure of the Koror–Babelthuaap Bridge in Palau, Fig 1, occurred on 26 September 1996, at around 5:45 in the afternoon¹. The collapse was catastrophic, killing two people and injuring four more, and occurred under virtually no traffic load during benign weather conditions. Services passing through the bridge between the country's two populated islands were severed; this caused the government to declare a state of national emergency and request international aid for the thousands of people left without fresh water or electricity.

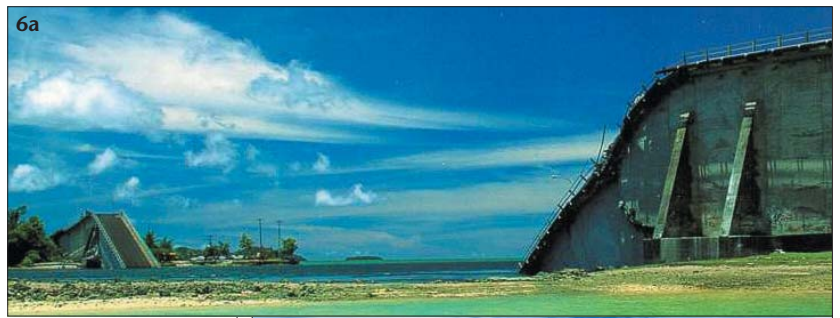
A design proposed by VSL International¹² was accepted, and construction was carried out by Black Micro (a local firm). There were four elements to this 'retrofit' (shown diagrammatically in Fig 5):

- Removal of the central hinge to make the structure continuous
- Installation of eight additional, external, post-tensioned prestressing cables inside the box section, running beneath the top slab near the main pier and, via two deviator beams on each side, moving to the bottom of the box near the centre. All these additional tendons were continuous through the bridge, being anchored between the piers on each side. 36MN of force was applied to these cables, creating a hogging central moment intended to remove 0.3m of the deflection.

- Insertion of eight flat-jacks between the top slabs, in place of the central hinge, which were used to apply an additional 31MN of longitudinal compressive force. These were grouted in place, making the span continuous. The combined effect of the external cables and flat-jacks will be referred to here as the additional prestress. The decision to make the bridge continuous was a late amendment to the design, and apparently taken on economic grounds since it allowed the new cables to pass from one half-span to the other and thus halved the number of anchorages required.

- Replacement of the bridge surface throughout. Because the prestress would not eliminate all the sag, a lightweight void former was to be inserted over the central area under the new surface, to provide a smooth running surface.

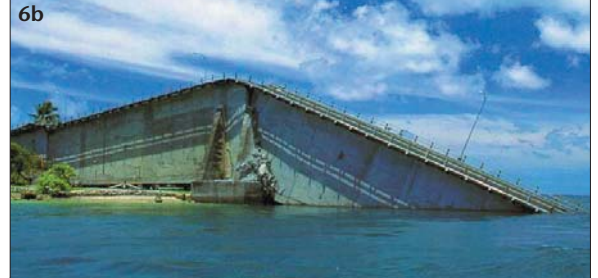
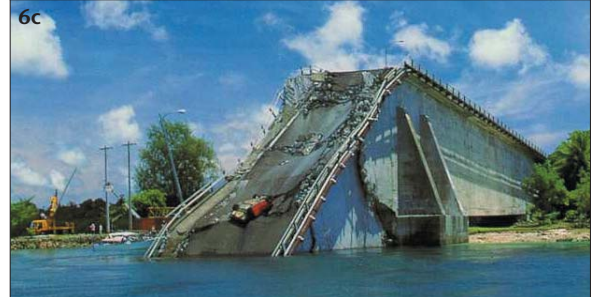
Fig 5. (left) Key features of original structural design and alterations made during remedial works
Fig 6. (above & right) Photos showing the bridge after the collapse²²
(a) the whole span viewed from the Babelthuap side
(b) Koror side (West)
(c) Babelthuap side (East)
(photo: © William E. Perryclear)

The bridge collapsed on 26 September 1996. A report prepared by SSFM for the US army¹³ describes in detail the most likely mechanism of collapse, inferred from eye-witness accounts and from visible damage to the bridge both above and below the waterline. Fig 6 shows pictures of parts of the bridge after collapse, in particular the area by the main piers on either side; a summary of the damaged regions is shown in Fig 7. The 'pockmarks' indicated in the figure were not mentioned in the SSFM report, but were discovered during later failure analysis.

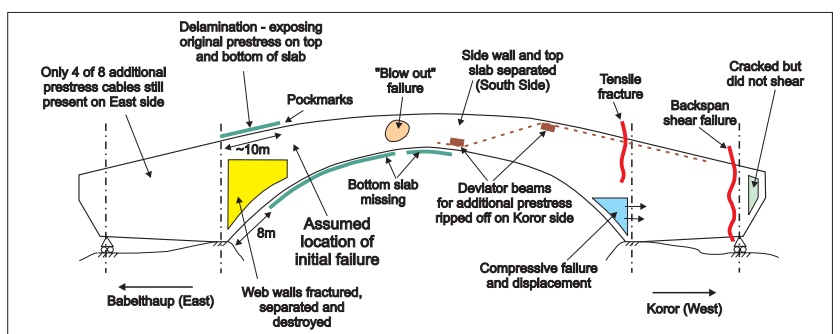
Fig 7. Damage to the bridge, as reported by SSFM after the collapse^{8,13}. Sketch only, not to scale

1. Delamination of the top flange occurred near the main pier on the Babelthuap side. This 'rendered it incapable of providing resistance against the original post-tensioning forces ... causing the rest of the girder to behave as a reinforced concrete girder spanning between the [centre] and the [Babelthuap] main pier'.
2. Large hogging moments resulted over the main pier, inducing far greater tensile stresses in the top slab and upper region of the webs than could be sustained. The webs therefore failed at the top, resulting in near total loss of their shear capacity. As a result, the Babelthuap side of the span failed in shear, next to the main pier.
3. The weight of both halves of the main span therefore acted on

the Koror side. Unable to sustain this increased load, the remainder of the bridge rotated around the Koror-side main pier, shearing the backspan just east of the end pier and lifting it temporarily into the air.

- The resulting compressive stresses just east of the Koror main pier caused the base of the box girder to crush and displace into the pier itself. The top slab then failed in tension, the backspan fell to the ground and the central span dropped into the channel.

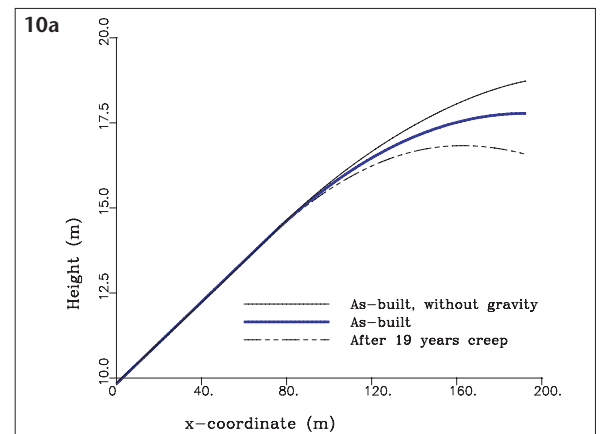
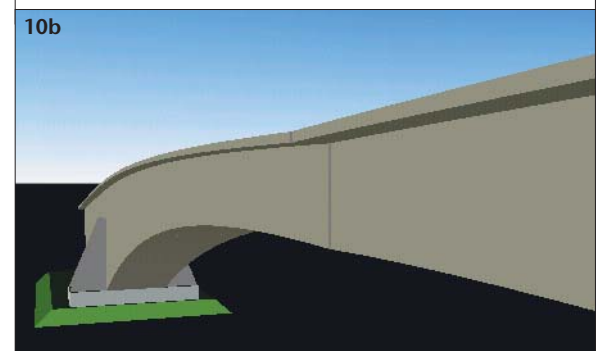
Fig 10.
(a) Top chord profile of bridge
(b) VR model at mid-span, showing effects of creep

If the concrete had a short-term Young's modulus (E) when cast of 30kN/mm^2 (which may be a little high), the tip deflection due to the beam's own self-weight would have been 0.95m . By assuming a creep factor ϕ , so that the effective modulus becomes $E/(1 + \phi)$, the observed creep deflection at the tip of 1.2m would have been produced by $\phi = 1.26$; this is based on creep affecting the concrete alone and does not take into account the untensioned reinforcement and the reduction of prestress due to creep. These values seem reasonable (although E should perhaps have been lower and ϕ higher), and the observed deflection due to creep should have been predictable. Fig 10(a) shows the profile of the top chord both as-built, and after 19 years of creep. The vertical scale is exaggerated but the kink that would occur at the centre is clearly visible. The top line shows the assumed profile of the bridge with the dead load removed; it is assumed that the bridge was built so that when complete it reached the desired alignment. The virtual reality image in Fig 10(b) shows, to scale, the kink at mid-span.

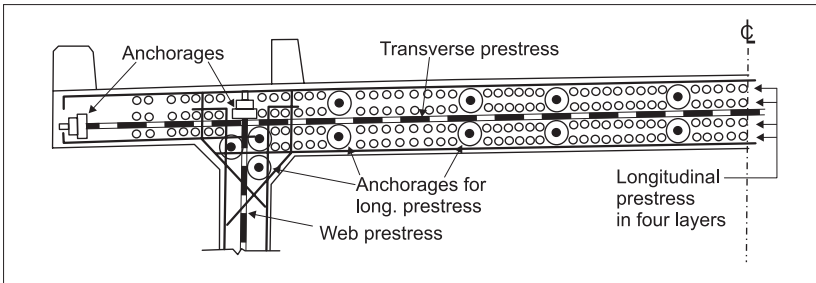
Fig 20. Detail of top flange - web connection⁸

The one remaining possibility is local damage to the top flange. Reports after the failure⁸ indicate that there had been some damage to the top flange, caused by removal of loose material prior to resurfacing. Up to 50mm of material had been removed in some areas. A check of the change in the stresses caused by a uniform removal of this amount of material shows only marginal variation (typically no more than 0.2MPa). It thus seems unlikely that this effect alone could have sufficiently altered the global stresses to cause failure.

There is, however, the possibility that the loss of material caused some local effects. Fig 20 shows details of the top flange (redrawn from ref. 8). There is considerable congestion of the prestressing steel; the top flange, which was 432mm thick, contained up to four layers of 32mm Threadbar tendons running axially and another running transversely. These tendons are available in relatively short lengths so there would have been frequent couplers, and the whole tendon was contained in ducts that would normally have had an external diameter of 51mm but which increased to 76 mm where the bars were coupled²⁰. The anchorage for the bar systems also has to be accommodated in the top flange, which required bearing plates 160mm square²⁰. The segmental nature of the original construction would have required a large number of both couplers and anchorages.

Taken together, the congestion of the prestressing ducts and the lack of tying and bursting reinforcement raises the possibility that local damage to the concrete led to weakening of the unreinforced concrete behind an anchorage. The collapse took place 6 weeks after the resurfacing was complete, which indicates that the process must have been relatively slow. The probability is thus

that the damage allowed the stresses locally to rise to such a level that fairly rapid creep of the concrete occurred behind the anchorage, which in turn led to damage to the concrete between the ducts, thus forming a plane of weakness. There would thus have been a sequence of events, which would account for reports that the failure took place slowly. It is probable that these weak planes led to the reported delamination that took place in the half an hour preceding the failure.

The conclusion that the failure was probably caused by local damage from over-enthusiastic scabbling of the surface, combined with an insufficiently robust design of the top flange due, in part at least, to congestion of the prestressing steel, rests on the absence of any other credible alternative. As Sherlock Holmes says in *The Beryl Coronet*: 'It is an old maxim of mine that when you have excluded the impossible, whatever remains, however improbable, must be the truth'. If this was the real cause of the problem, then there are lessons for the wider engineering community about the detailing of prestressed concrete slabs. If a major concrete structure can be brought down by one over-enthusiastic worker with a road breaker, then more extensive robustness requirements are needed. It also implies that the structure had been at risk throughout its life.
