Why did Palau Bridge collapse?

Synopsis

The failure of the Koror–Babelthuaap Bridge in Palau, Fig 1, occurred on 26 September 1996, at around 5:45 in the afternoon¹. The collapse was catastrophic, killing two people and injuring four more, and occurred under virtually no traffic load during benign weather conditions. Services passing through the bridge between the country's two populated islands were severed; this caused the government to declare a state of national emergency and request international aid for the thousands of people left without fresh water or electricity.

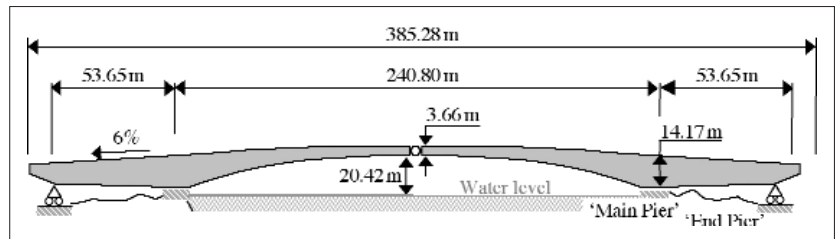
Fig 1. (left) The Koror-Babelthuaap Bridge prior to collapse²² (photo: © William E. Perryclear)
Fig 2. (below) Elevation showing bridge geometry, as built

The bridge cost \$5.2M to build, and was completed in April 1977, after which it remained unchanged for the next 18 years. Over this period the cantilevers deflected due to creep, shrinkage and prestress loss. By 1990 the sag of the centre line had reached 1.2m (visible in Fig 1), affecting the appearance of the bridge, causing discomfort to road users, and damage to the wearing surface. The Palauan government commissioned two teams of experts to assess the safety of the structure and its ability to continue to carry the design loads in the future. Louis Berger International (USA) and the Japan International Cooperation Agency both concluded that the bridge was safe and would remain so, but the deflection could be expected to increase further in the future (by another 0.9m over the next 100 years). As a result, the decision was made to put out to tender remediation works to correct some of the sag and prevent further deflection⁸.

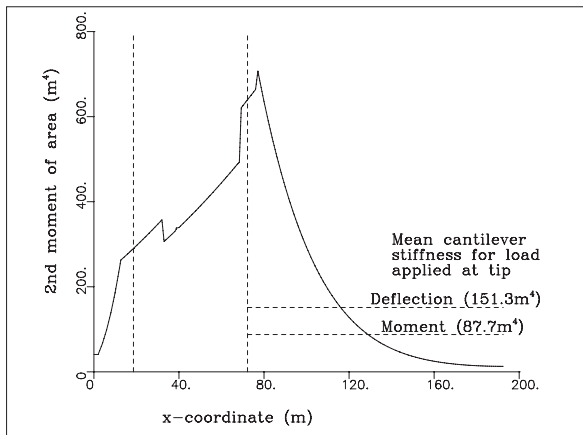
Fig 9.
Variation of second
moment of area in
one half-span

The detailed geometry¹¹ of one half of the structure is shown in Fig 8, and the corresponding second moment of area is shown in Fig 9. The x-coordinate used here is measured from the extreme

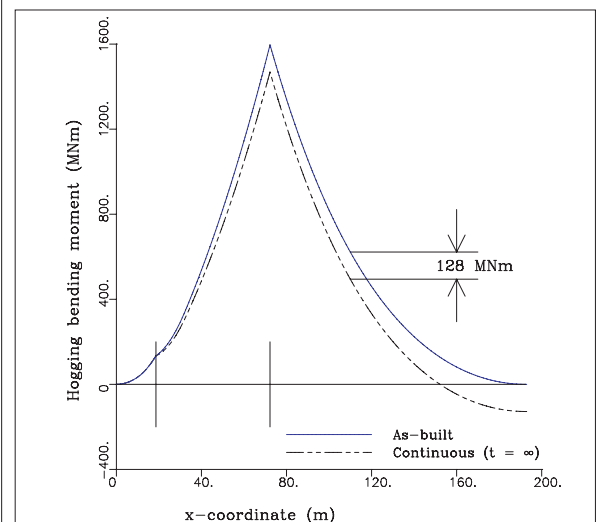
Fig 11. Dead-weight bending moment diagram, including ballast

Fig 11 shows the as-built bending moment diagram due to the bridge's own dead weight for one cantilever, as a solid line. There is, of course, no question about these values since the structure was at that stage still statically determinate. The plotted values include the effect of the ballast in the back-span, since this is a permanent load. The ballast was sufficient to ensure a compressive reaction at the end pier, which nevertheless was provided with a tie-down. The peak moment at the main support is 1596MNm, while at $x = 86\text{m}$ the moment is 1165MNm and the shear force 27.9MN.

Making the structure indeterminate allows the possibility of moment redistribution due to creep. All other things being equal, the structure would creep towards the bending moment diagram that would have resulted if the structure had been built monolithically. Analysis, taking account of the variation in stiffness, shows that the sagging moment at mid-span under these assumptions would be 128MNm; the resulting bending moment diagram is shown dotted in Fig 11. The difference is much less than would be expected in a beam of uniform cross-section but is understandable given the relatively low stiffness of the tips of the cantilevers.

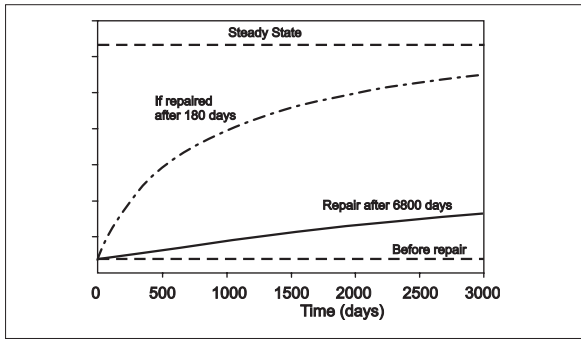
Fig 12. Change in support reaction with time due to thermal creep

Xu¹⁷ has carried out an analysis of Palau on the assumption that the structure is continuous, that the top and bottom flanges are at uniform temperatures of 29.2°C and 24.2°C respectively (it is in the tropics!) and that the *in situ* joint is 1m wide. Fig 12 shows the change in support reaction with time, which is a direct reflection

tion on the speed with which the redistribution occurs. Detailed values are not given since a slightly different set of assumptions was adopted from that used in the rest of this paper, and what is important is not the amount of redistribution that occurs, but the speed with which it take place. The lower dashed line shows the moment when the central hinge is made continuous and the prestress has been applied. The upper dashed line shows the steady state value predicted by England's theory, to which the structure would eventually become asymptotic.

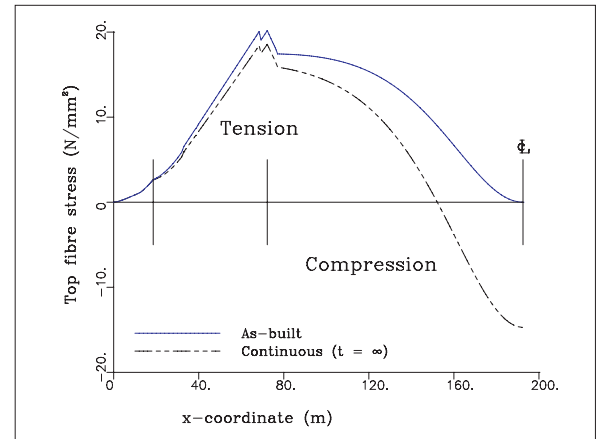
Fig 13. Bending stresses due to dead load and ballast

Even if these creep effects had occurred, it is doubtful that they would have caused any problems. The effect of the bending moments (from Fig 11) on the top fibre stresses is shown in Fig 13; no account is taken here of any prestress. The as-built stresses are tensile (+ve) everywhere. The reduced inertia at the tip of the cantilever means that the sagging continuity moment has a relatively large effect on the stress near the centreline. The values shown in the figure are for the top fibre, and are thus compressive at the centreline, but there are corresponding tensile stresses in the bottom flange. As far as is known, no continuity steel was placed across the joint when the structure was made continuous, and the additional prestress that was added (to be discussed below), was placed in the top flange.

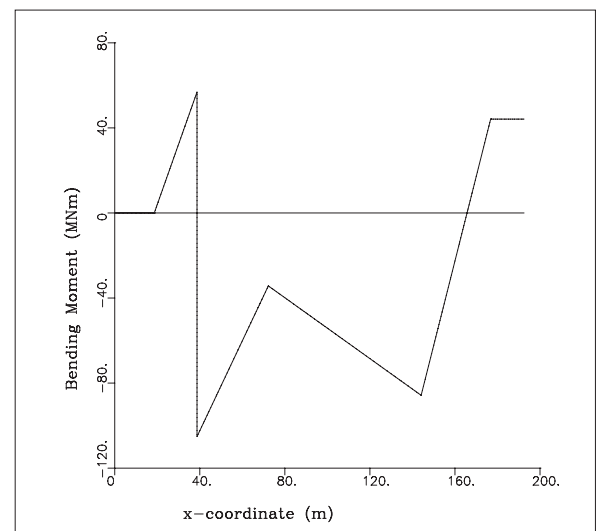
Fig 14. (above) Forces induced by continuity cables
Fig 15. (right) Bending moments induced in the continuous structure due to the continuity cables

The continuity cables pass along the full length of the structure, which at this stage has been made continuous. They make contact with the concrete only at the anchorages and at the deflector beams. The forces exerted by the cable on the bridge are shown in Fig 14. Note that there is no force applied to the bridge at the

Thus, it is concluded that the effect of these cables is limited to the bending moments shown in Fig 15, which have been obtained by analysing the bridge under the loads shown in Fig 14, assuming full continuity at the centre. At $x = 86\text{m}$ this gives a moment of 44MNm (sagging) and a shear force of 0.7MN. These are small by comparison with the values due to the beam's own dead weight.

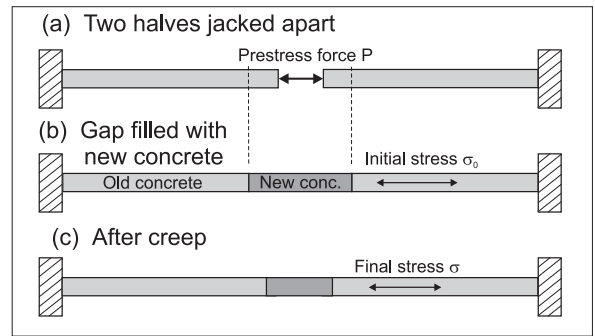
Fig 16. (above) Forces due to flat jacks at centre
Fig 17. (right) Modelling effect of flat jacks over time

Flat jacks were installed between the two cantilevers which were jacked apart with a force of 31MN applied at the centre of the top flange, as shown in Fig 16.

Due to the change in cable profile, a prestressing tendon exerts forces on the concrete all along its length, so the moment is a function of the cable eccentricity at any position, but the force applied by a jack directly on the concrete retains its line of action throughout the structure. The difference in height between the centre of the top flange at the tip, and the centroid at $x = 86\text{m}$ is 10.23m,

so this jack exerted a sagging moment of 317MNm at the critical location. Once the structure has moved, the gap was filled with new concrete, and it is this concrete that continued to apply the force rather than the jacks.

An analysis has been carried out of a simplified problem, as shown in Fig 17, in which two pieces of concrete are forced apart axially and new concrete inserted. This was then analysed using the age-adjusted effective modulus method^{18,19}, and the variation of force with time plotted as shown in Fig 18.

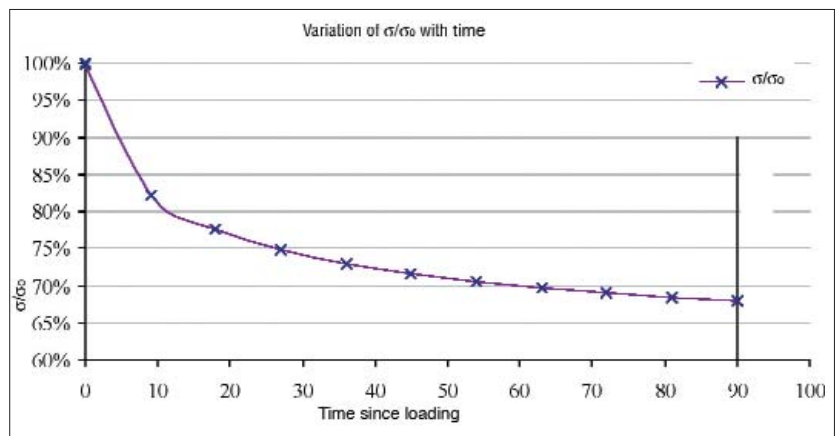
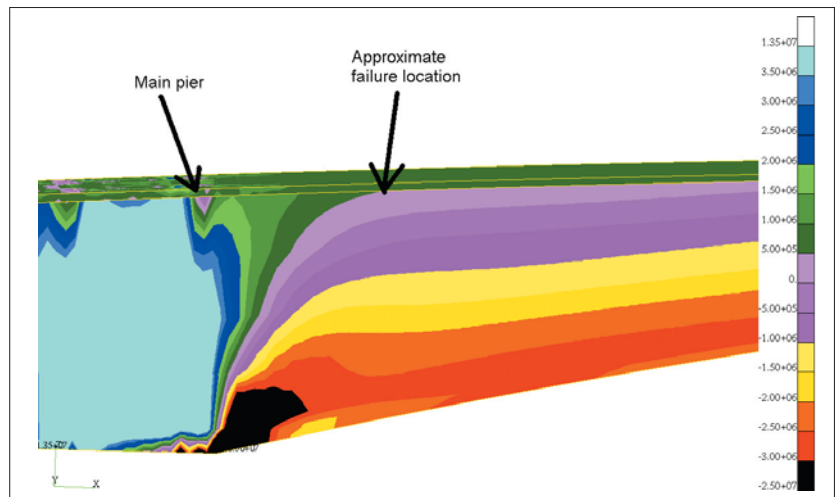
Fig 18. (below) Effect of creep in the *in situ* joint on the stress due to the flat jacks
Fig 19. (bottom) Vertical shear stress in web near failure location, varying from - 3MPa at base to 0.5MPa at top

Thus, it is concluded that there were no peculiar local stress-concentration or shear-lag effects which could have caused problems near the failure zone.
